Eastleigh
BSAC
“What
Lies
Beneath”
Report
2013,
The ‘O’
Wreck

Year 1, report detailing EBSAC’s investigations, survey and diving at
WLB Site Number 11 – 19949.

Author: A. Hermiston

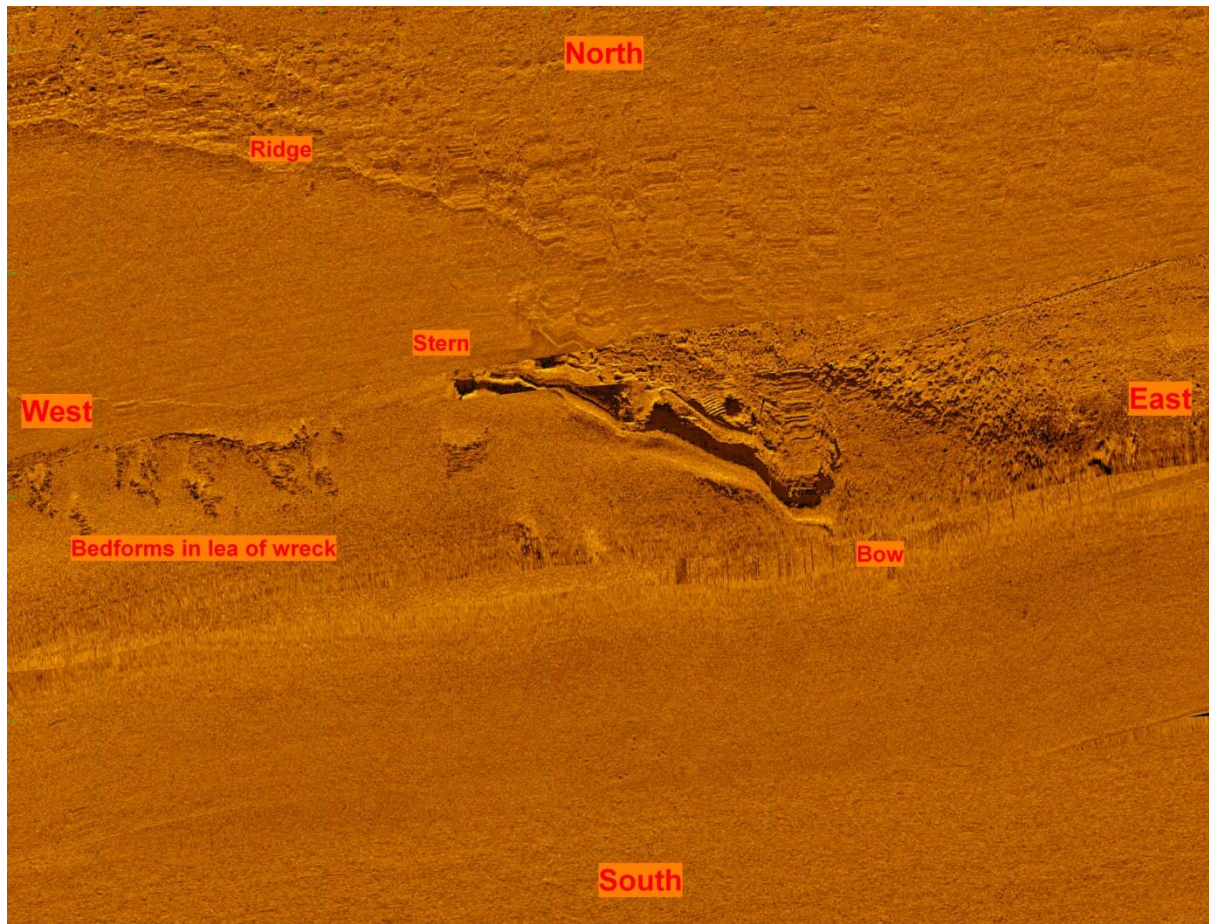
Figure 2, wreck site.

The wreck lies in a general water depth of 31m at LWN and has a least depth of about 25m over the central section in the vicinity of the boilers. It makes a strong sonar contact and the site covers an area of approximately 60m by 13m, is orientated 110/290° and is lying on a small mound in the sea bed. The wreck appears to be quite compact without an extensive debris field, although a few sand patches overlies the gravelly seabed in the lea of the wreck to the west, Figure 2.

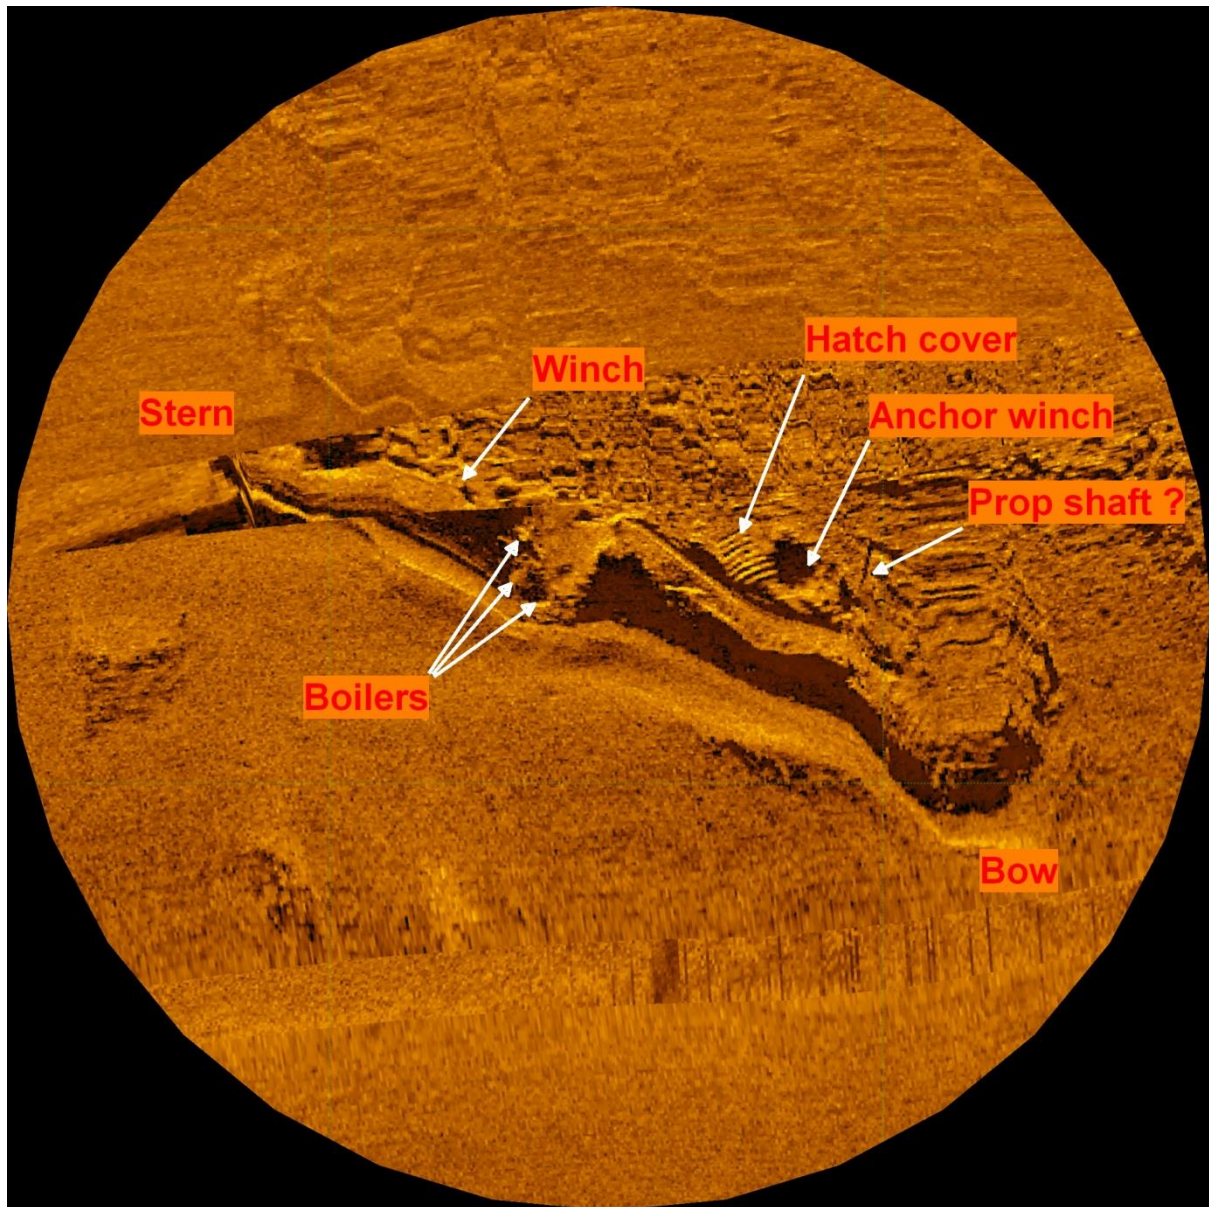
Figure 3, detailed sonar image of the wreck.

Within the wreck some internal structures can be seen, the most intriguing of these are:

- Mast or prop shaft,
- Winches.
- A collection of seven well defined linear reflectors covering an area 6m by 6m that may form part of a hatch cover, and
- The boilers which are amidships in the most intact section of the vessel.

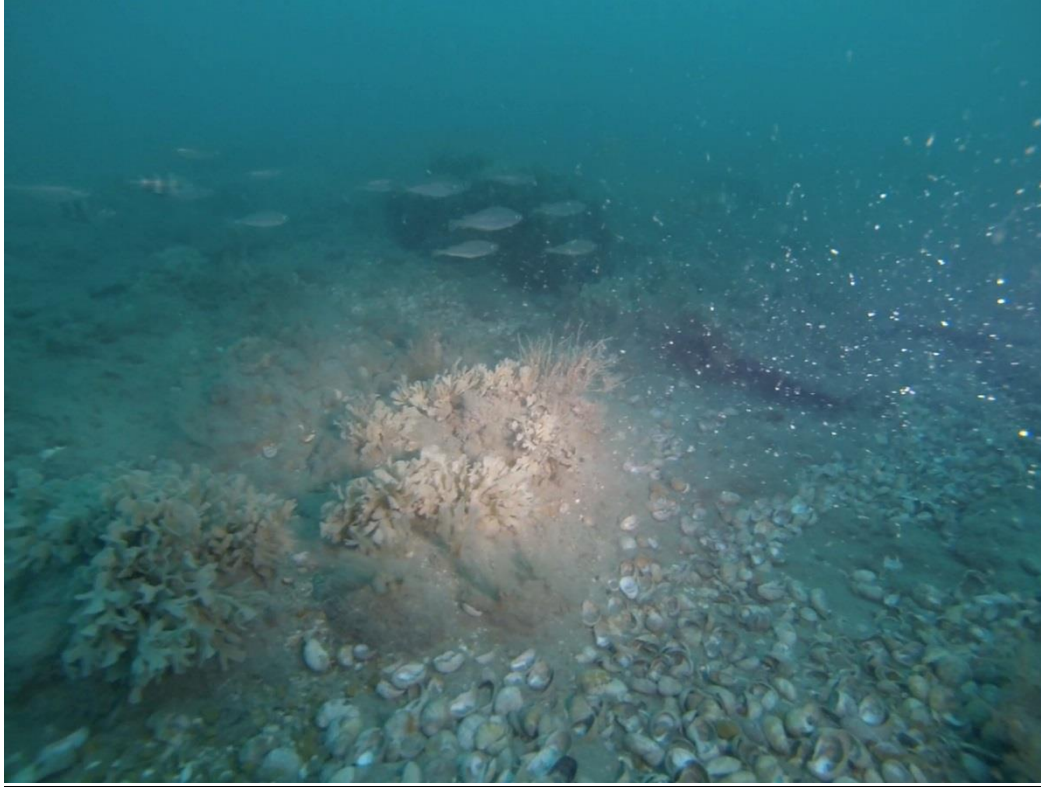
The seabed by the bows consists of sands and gravels with shells and abundant cobbles; the seabed appeared to be stable as evidenced by the extensive marine flora, bryozoans being particularly evident, Photo 8. Adjacent to the keel, sands and shell had accumulated partly burying the port side of the hull and within the wreck sands and shell were present.

Photo 8, Seabed close to the wreck's bow.

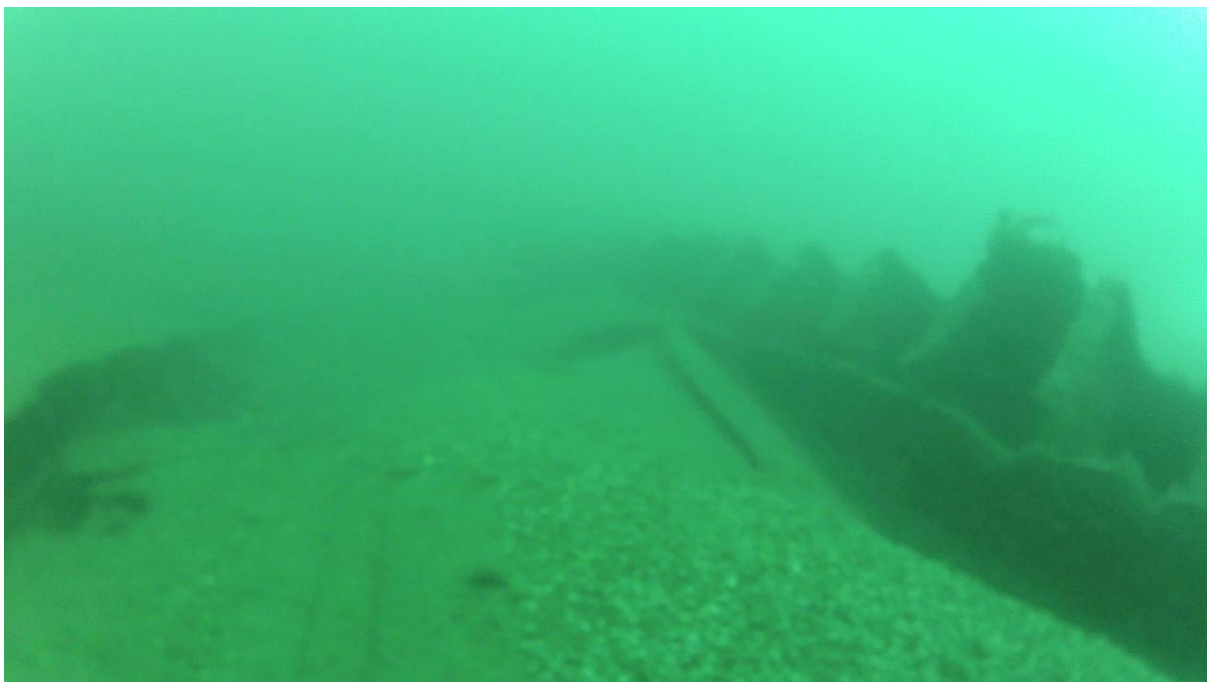
The wreck is lying on its portside; the keel is intact and can be followed from the turn of the bow, at the stem post, to the stern post by the rudder stock which encloses the propeller aperture. Foreword of the boilers, the hull has collapsed and has broken away from the keel revealing the internal frames within the keel section, Photo 9. The starboard hull has fallen into the hold and forms a low lying flat area devoid of many features; it has been displaced from the keel by about 1 to 2 meters. One interesting feature on the hull plating that can be traced along most of the wreck, at the former deck level, is a "U" shaped channel that may have contained wooden fendering, Photos 10 & 11 Deck fittings are also found scattered on the seabed beyond the hull plating at what would have been deck level.

Photo 10, Shows the hull which has broken off from the keel and has been partly covered by sand and shells.

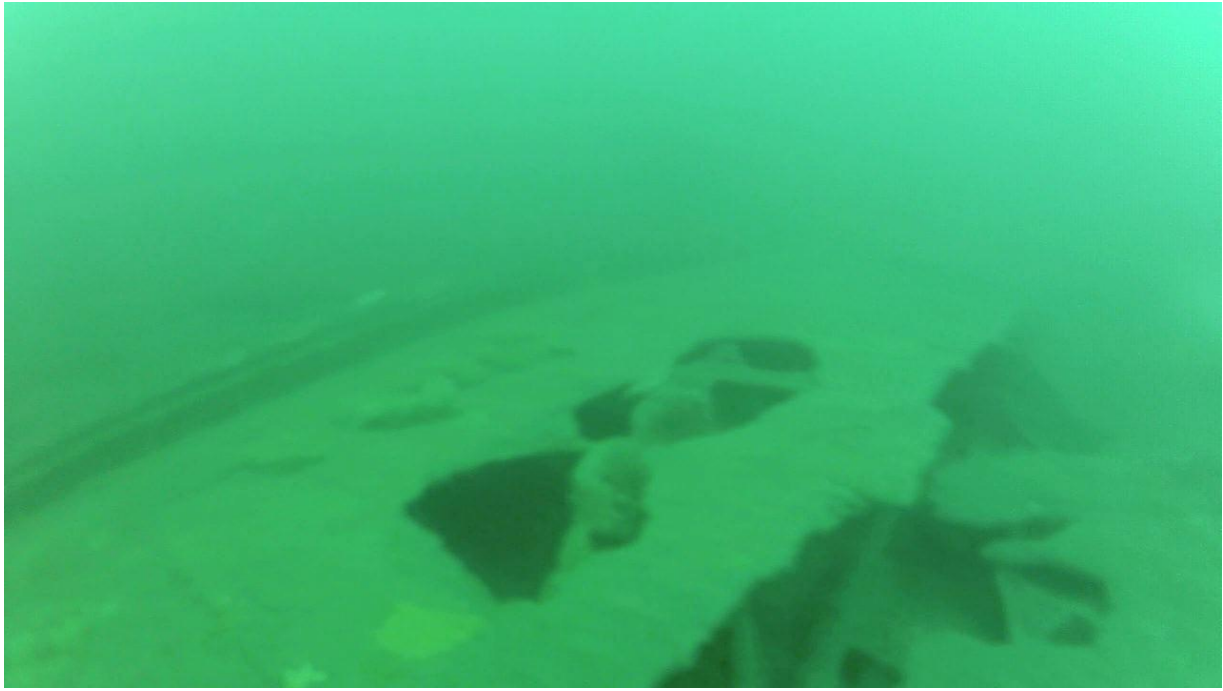
Photo 11, Hull section showing a channel appearing on the left of the photo and disappearing into the murk in the photo's centre. It probably held wooden fendering as it was located close to the deck level.

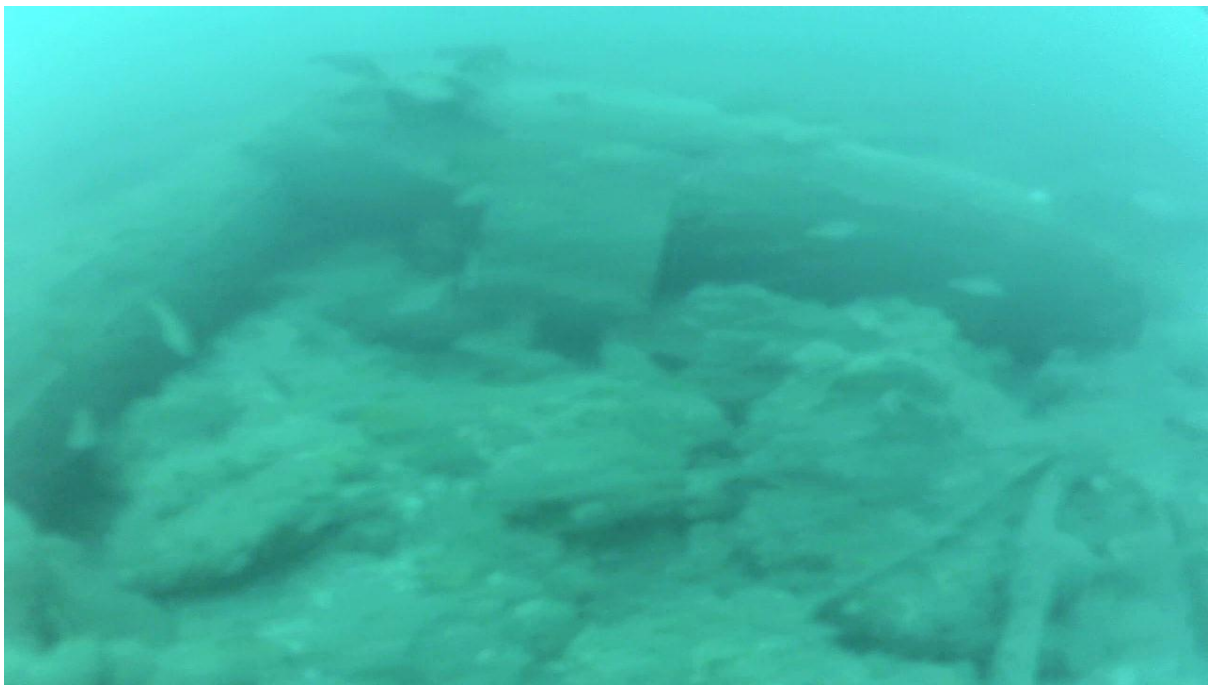
Traversing from the bows towards the stern the first main deck feature seen is a mast. It is of riveted, hollow tube construction, has been broken off at its base and has a set of belaying pins approximately 1.5 metres above the break; a line of rivets can be seen in this area. The mast has been bent into a ninety degree bend just above the belaying pins, Photo 12.

Photo 12, Section of mast.

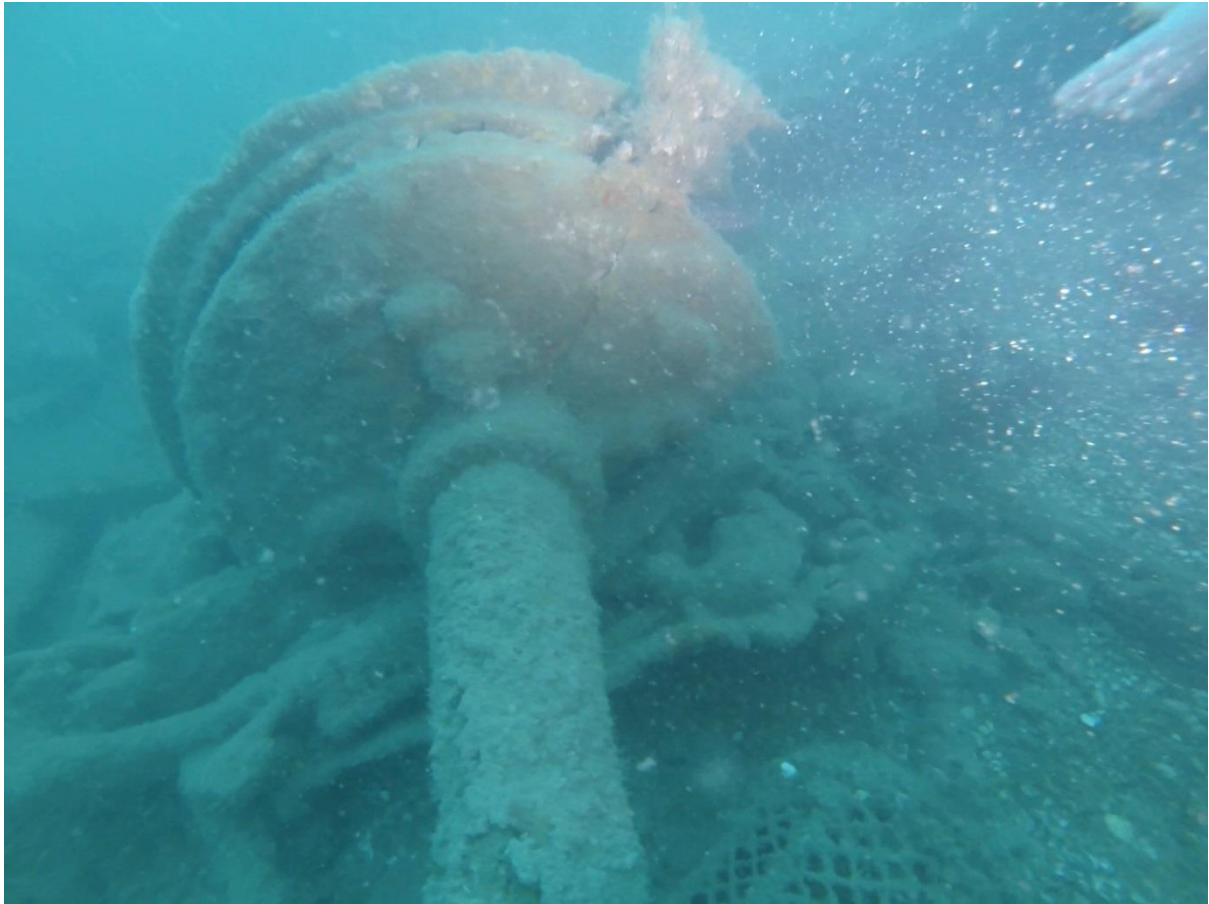
The next feature is rather intriguing, which we have interpreted as part of the prop shaft and we believe that it has been dislodged by fishing or anchoring activity. It comprises of a sizable solid shaft that passes through a circular housing in which there appears to be a bolted flange, connecting two halves of the shaft together, and can be seen below the conger eel's tail. The shaft continues through the circular housing for some distance, approximately 2.5 to 3.5 metres, and terminates at a bearing attached to a steel plate with ragged edges, suggesting it has been ripped from a bulkhead or similar, Photos 13 & 14.

Photo 13, Displaced prop shaft and bearing assembly.

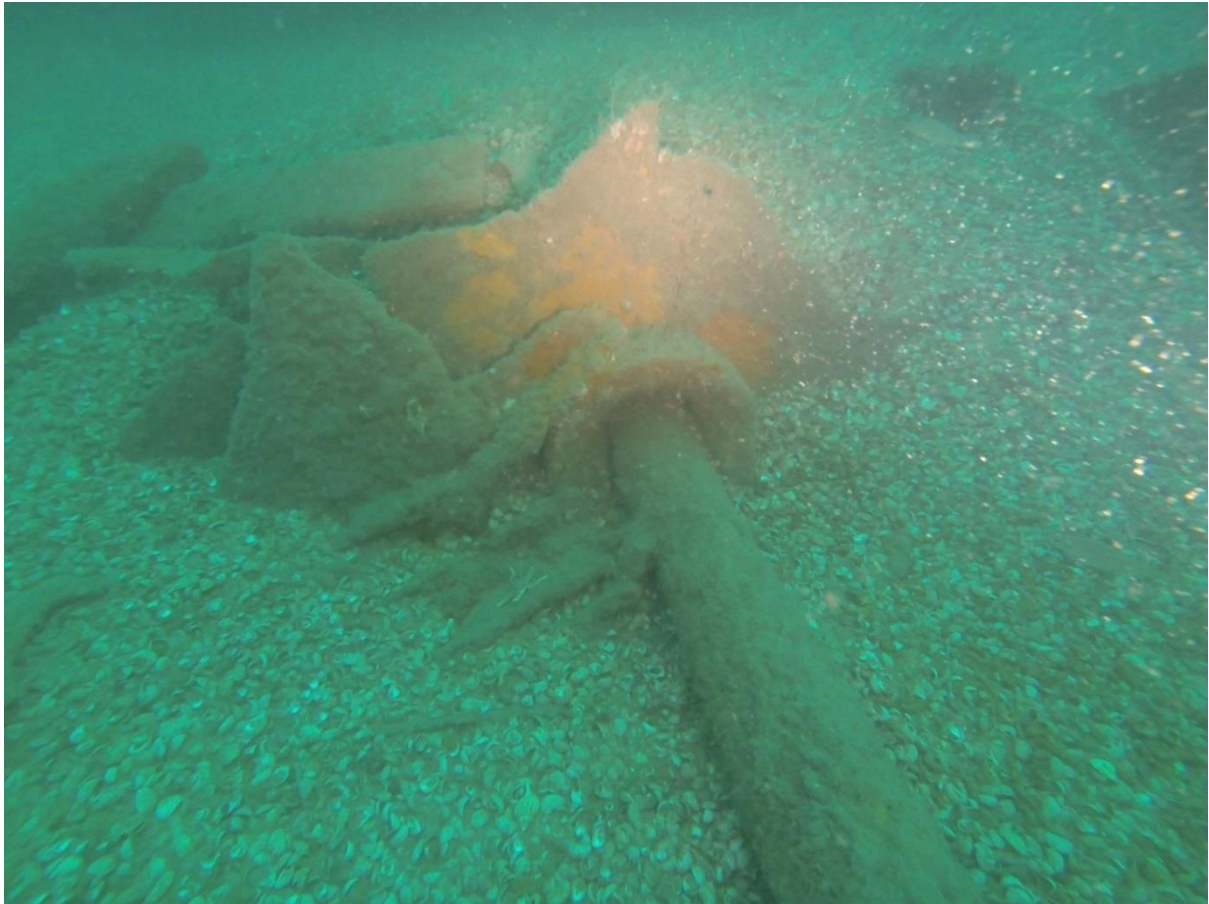
Photo 14, Opposite end of the displaced prop shaft seen in Photo 12. Note the ragged edges to the bulkhead housing a bearing.

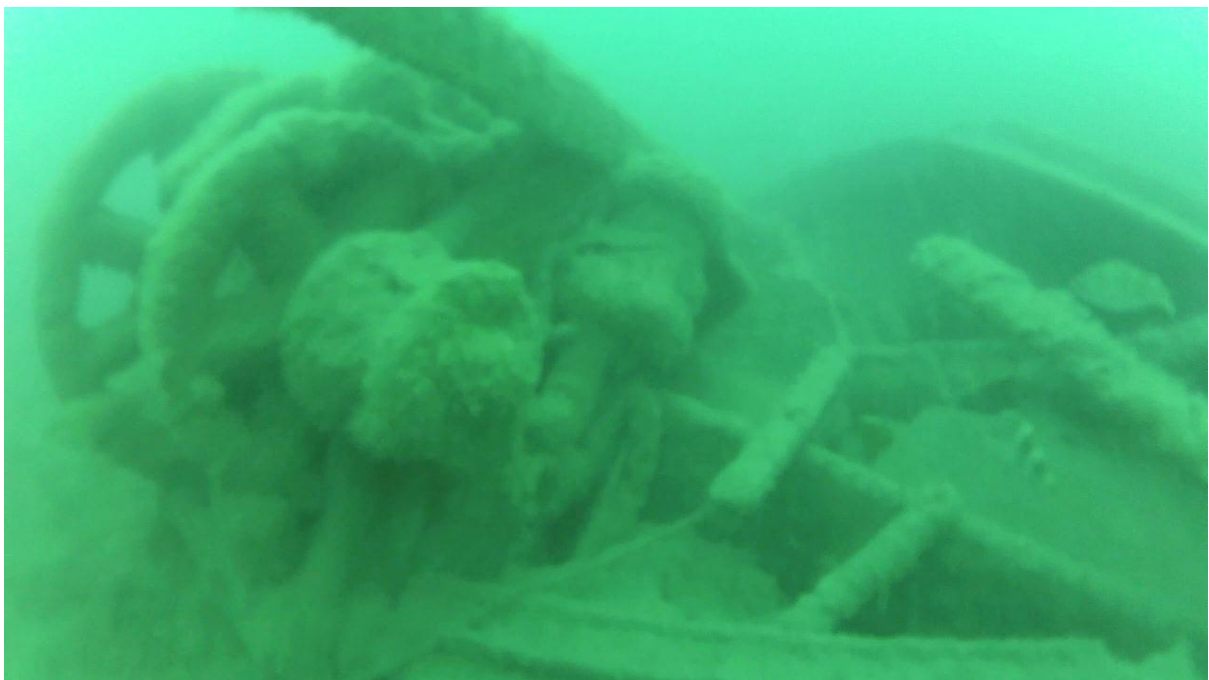
The steam anchor winch, complete with warping drums, is lying upside down in the middle of the hold. Part of the supporting sub frame can be seen behind the steam piston, Photo 15 & 16. We concluded that it was the anchor winch due to the narrow drum length between the two gear wheels and fair lead seen adjacent to the winch. It was of similar size and construction to the anchor winch present on the SV Concha (formally known as the Ore wreck) off Littlehampton; which was investigated by Wessex Archaeology as part of an ASLF funded project "Wrecks on the seabed R2, Assessment, Evaluation and Recording".

Photo 15, Steam anchor winch lying upside down.

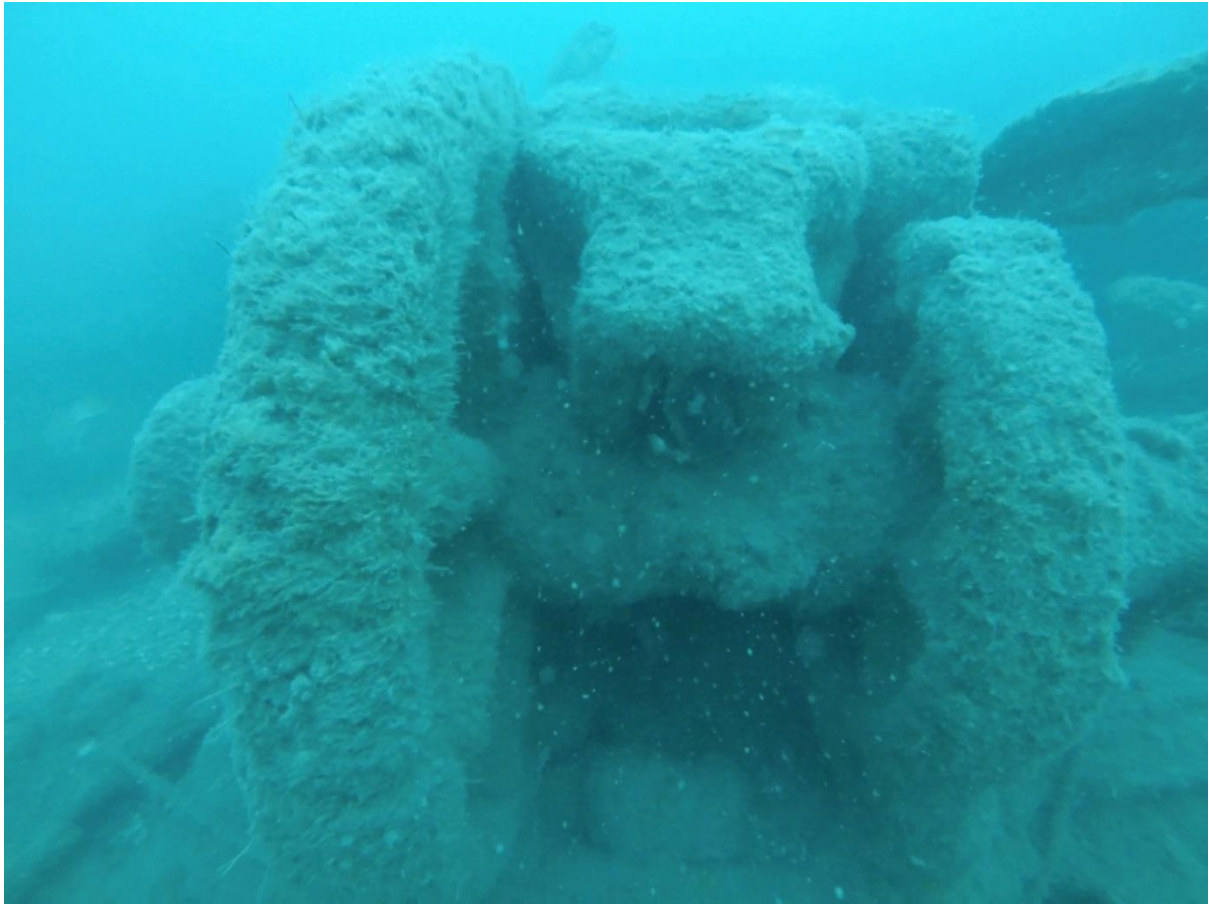
Photo 16, head on view of anchor winch and gear wheels.

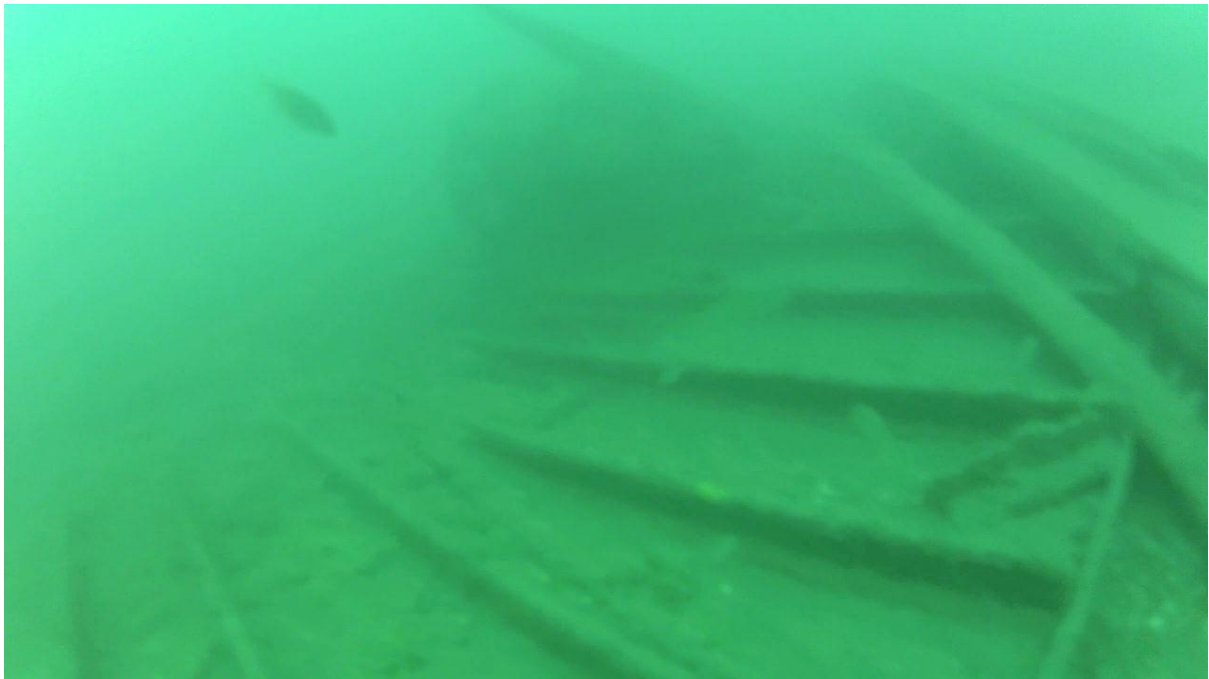
Part of a hatch cover can be seen just aft of the winch with the hull lying over a portion of the cover (note in the video it is shown before the winch due to the sequence in which the wreck was filmed), Photo 17. The hatch cover's strengthening frames made an excellent acoustic target for the side scan SONAR and can be clearly identified in the sonar images.

Photo 17, Hatch cover seen so distinctively on the side scan SONAR records.

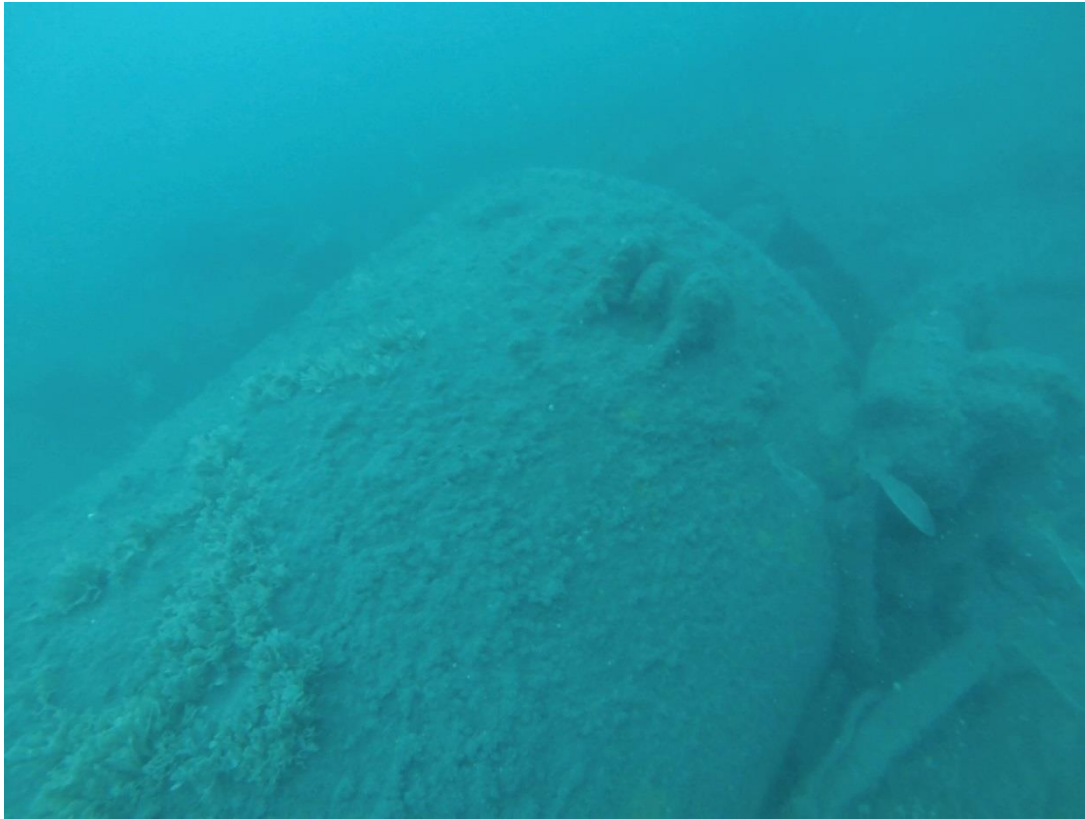
The donkey boiler is lying on the seabed on the deck side of the wreck site close to the main boilers. It is lying on its side with the ash pit and furnace door visible at its base. The inside of the boiler can be seen through a hole in the boiler's casing showing the construction of the furnace. Towards the top of the boiler's casing an inspection hatch and steam relief valve are present, Photo 18. Just aft of the Donkey boiler are a hatch and a set of mooring bits.

Photo 18, Top section of donkey boiler showing inspection hatch and steam valve.

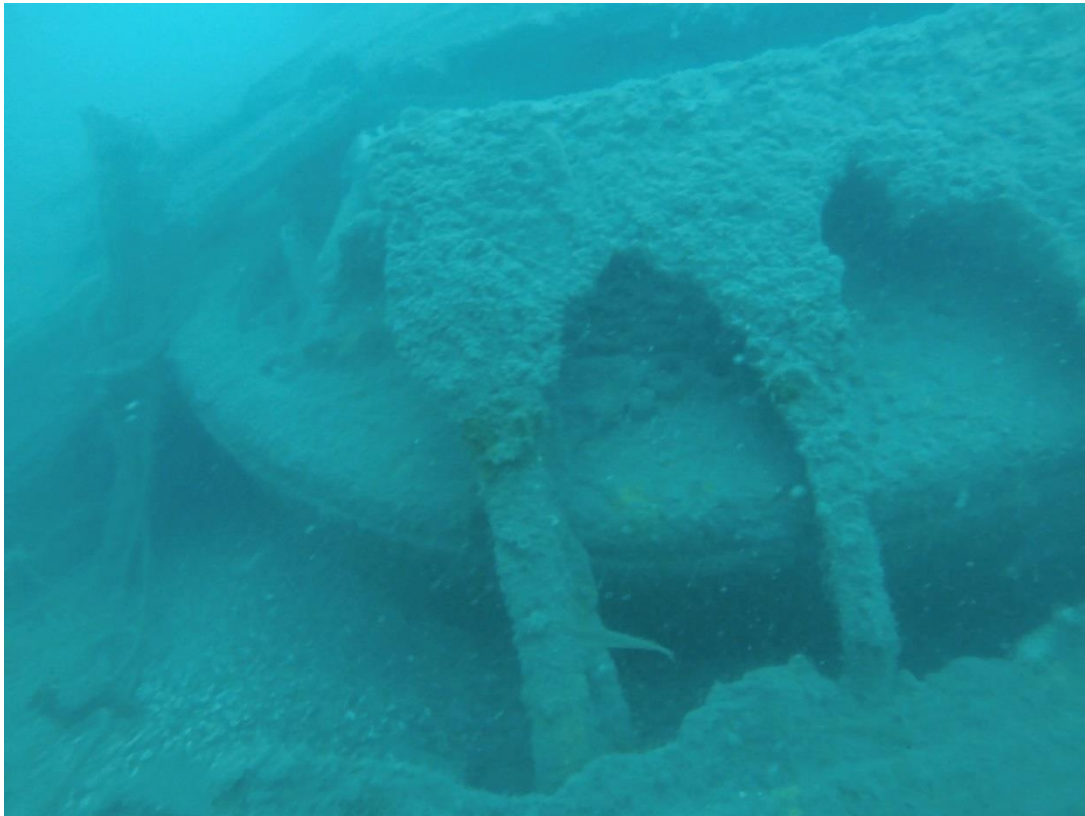
It is interesting to note there are two main boilers which is unusual for a ship of this size. The port boiler is in its original orientation within the ship's structure but the starboard boiler, which would have been parallel and on top of the port one when the ship came to rest on the seabed, appears to have broken free of its mounting to fall beside the port boiler resting on its stern end. Following this the unsupported starboard hull has broken and fallen across both boilers. Over the years the hull plating has corroded away leaving gaps between the ribs allowing the boiler features to be seen. A light hearted illustration of this theory is presented in the wreck tour video. An inspection hatch and steam valve can be seen on the port boiler, whilst the starboard boiler clearly shows the fire tubes, stays, furnace and ash pit. The internal surface of the furnace is corrugated, indicating it may be a Lancashire boiler and the furnace door can be found close by, Photo 19 & 20.

Photo 19, Boiler lying on its aft end, with exposed fire tubes and overlain by the hull ribs.

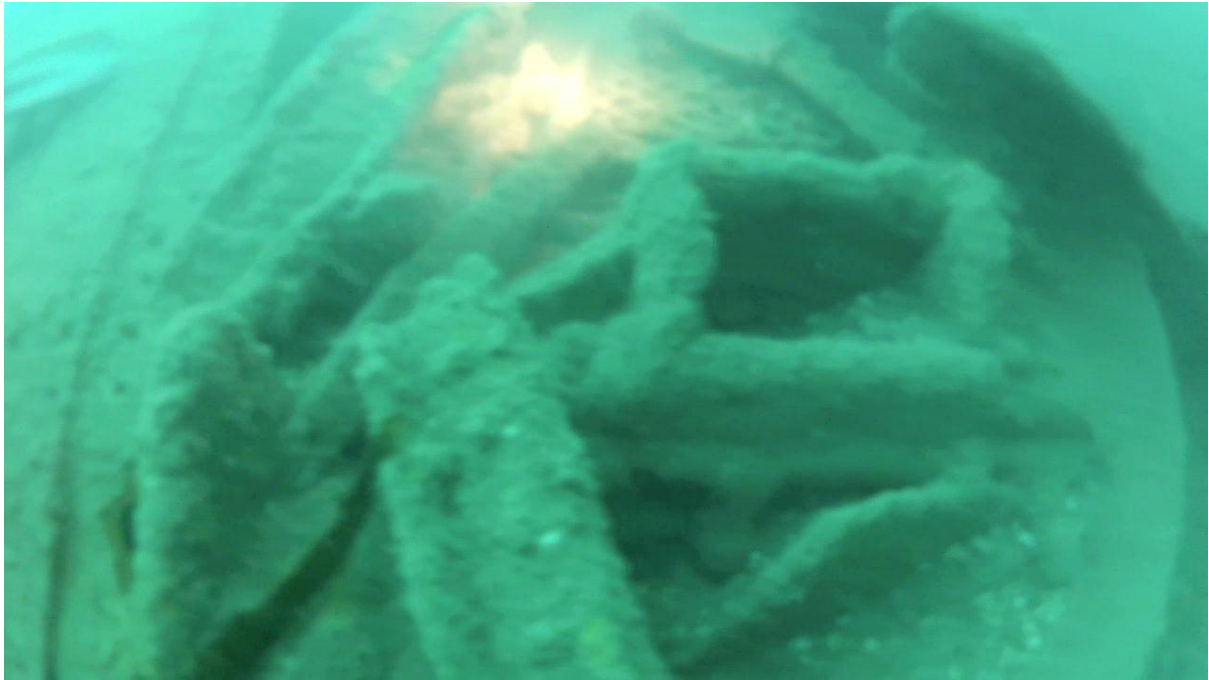
Photo 20, Boiler showing ash pit, furnace door and fire tubes.

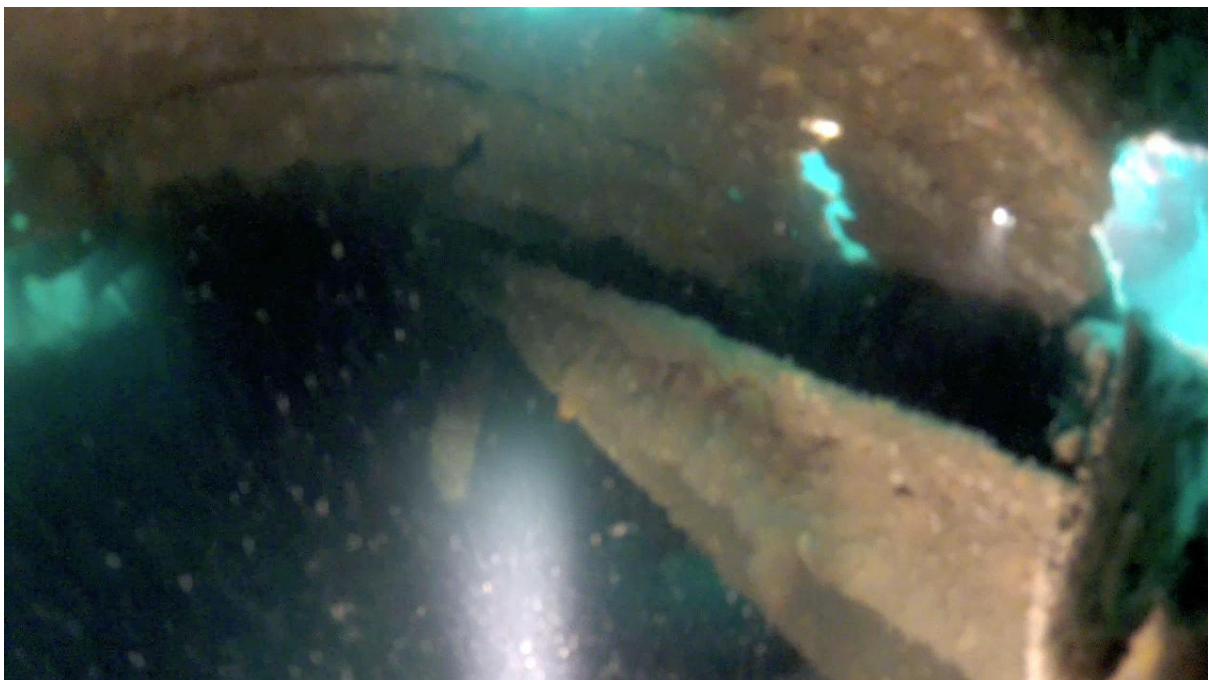
The hull at this point has been partly draped over the boilers and probably obscures access to the engine, although a narrow passage was found next to the boiler leading under the hull plating, Photo 21. Minimal diver penetration took place to establish the extent of this passage but due to additional gas and equipment required for wreck penetration this exploration was left for another dive.

Photo 21, Tunnel under collapsed hull plating adjacent to the boilers which may give access to the engine.

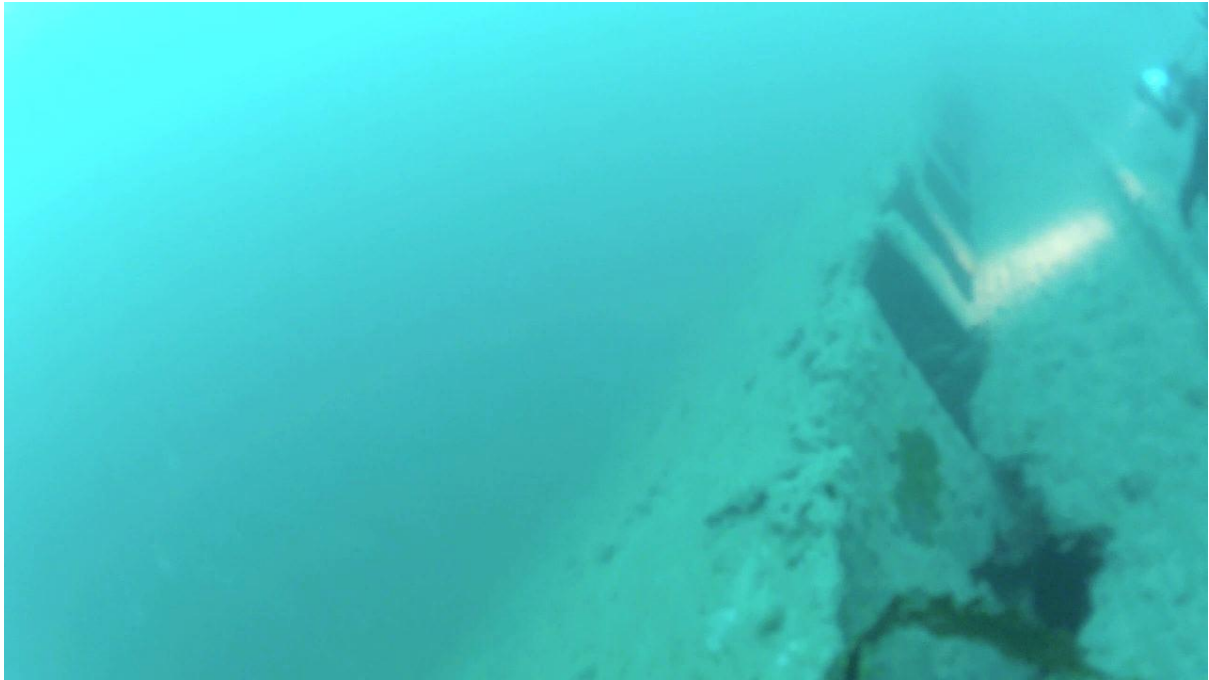
The hull plating at the aft end of the wreck has broken away from the keel in a similar fashion to that seen in the forward section but has been displaced vertically downward revealing the internal frames, Photo 22.

Photo 22, The hull can be seen broken away from the keel and displaced downwards at the aft end of the wreck.

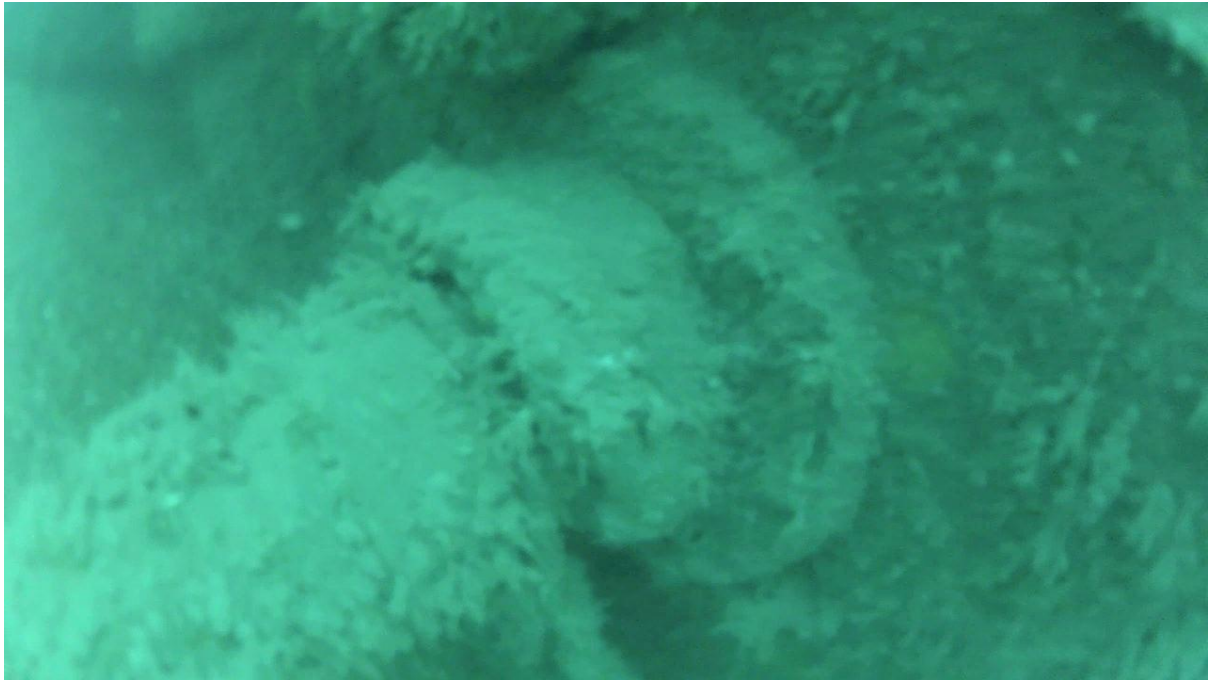
The stern of the wreck is interesting with part of the propeller shaft protruding into the inner space of the wreck through a bulkhead and bearing, Photo 23 & 24. The other side of the bulkhead there are a series of closely spaced frames supporting the stern tube and the propeller shaft can be seen in the deep 'V' hull profile at the very stern of the wreck.

Photo 24, Close up of bearing seen in Photo 22.

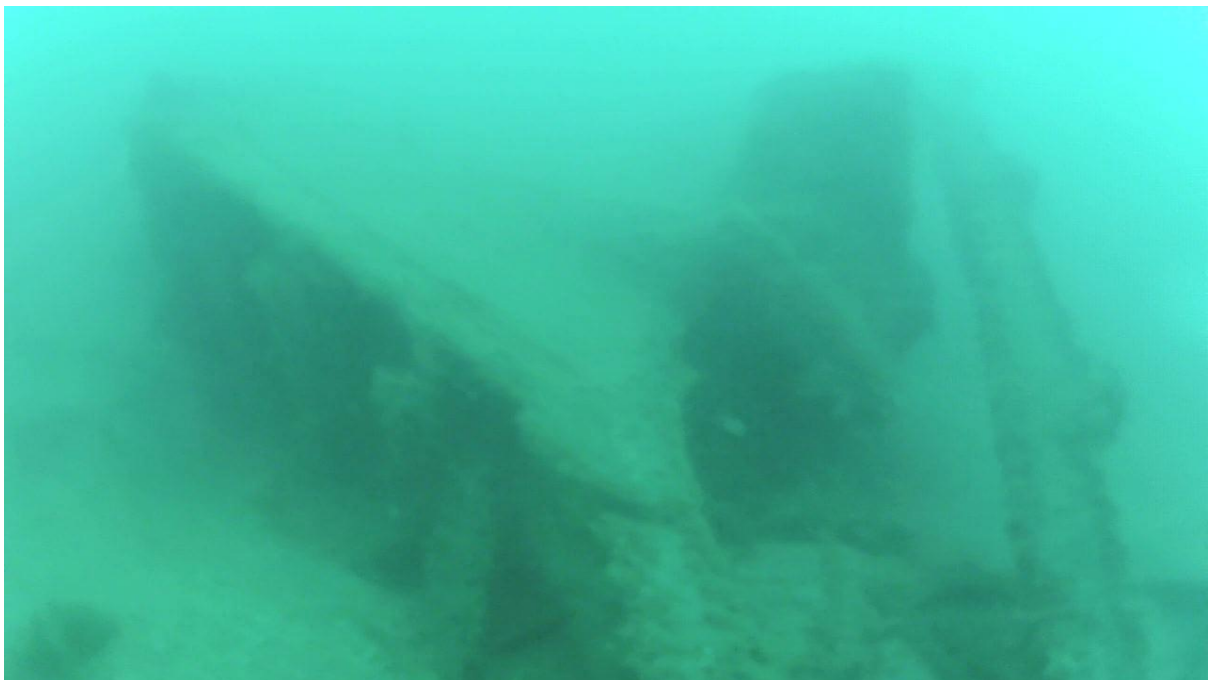
From outside the wreck the stern tube and brass stern gland can be clearly seen protruding through the hull profile; attached to the propeller shaft is a four bladed iron propeller but two of the blades have been partially broken off, Photo 25, 26 & 27.

Photo 25, Shows the stern section in context, the first bulk head seen in the top left of the photo is the reverse side of the bulkhead shown in photos 22 & 23. The prop shaft continues through a series of bulkheads emerging through the hull at the stern gland and is attached to a four bladed iron propeller. At least two of the blades have been broken off the other two are buried in the seabed. Behind the propeller the stern post can be seen with pintails for attaching the rudder, which we did not find.

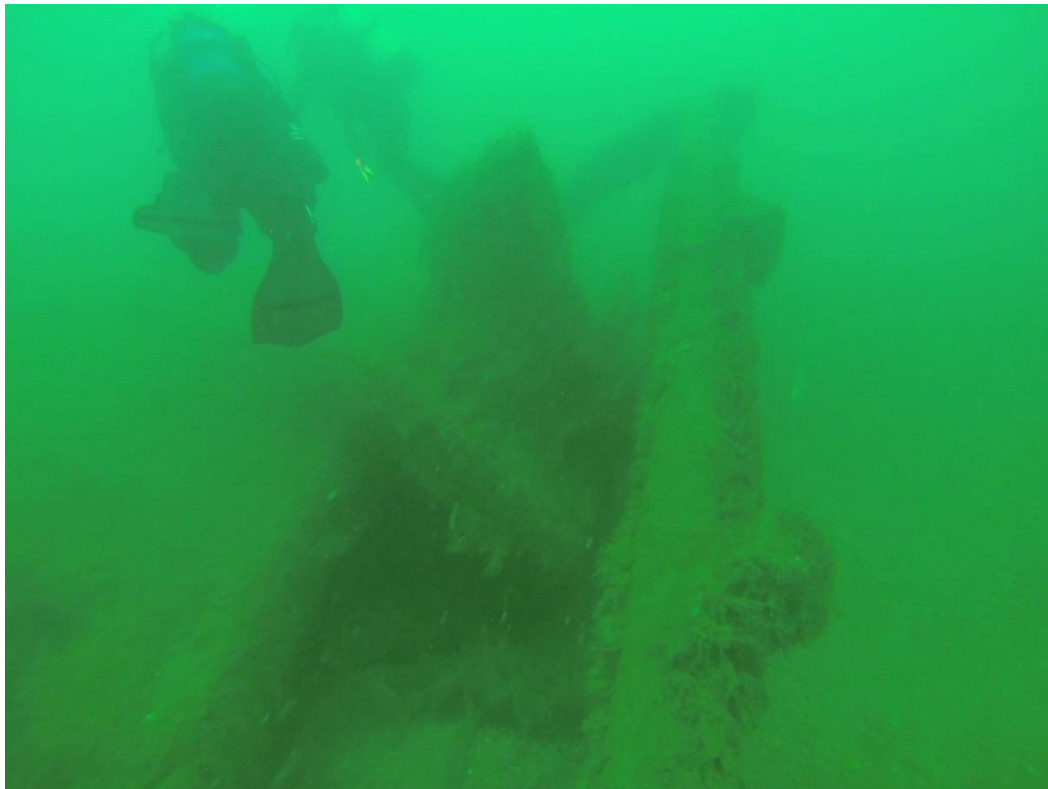
On the stern post there are the remains of pintails that would have held the rudder in place. Aft of this point there was a small amount of additional wreckage scattered around which could have been the rudder but was not investigated due to time limits and decompression penalties.

Photo 26, Close up of pintails and rudder.
