Eastleigh
BSAC
“What
Lies
Beneath”
Report
2013,
The ‘O’
Wreck

Year 1, report detailing EBSAC’s investigations, survey and diving at
WLB Site Number 11 – 19949.

Author: A. Hermiston

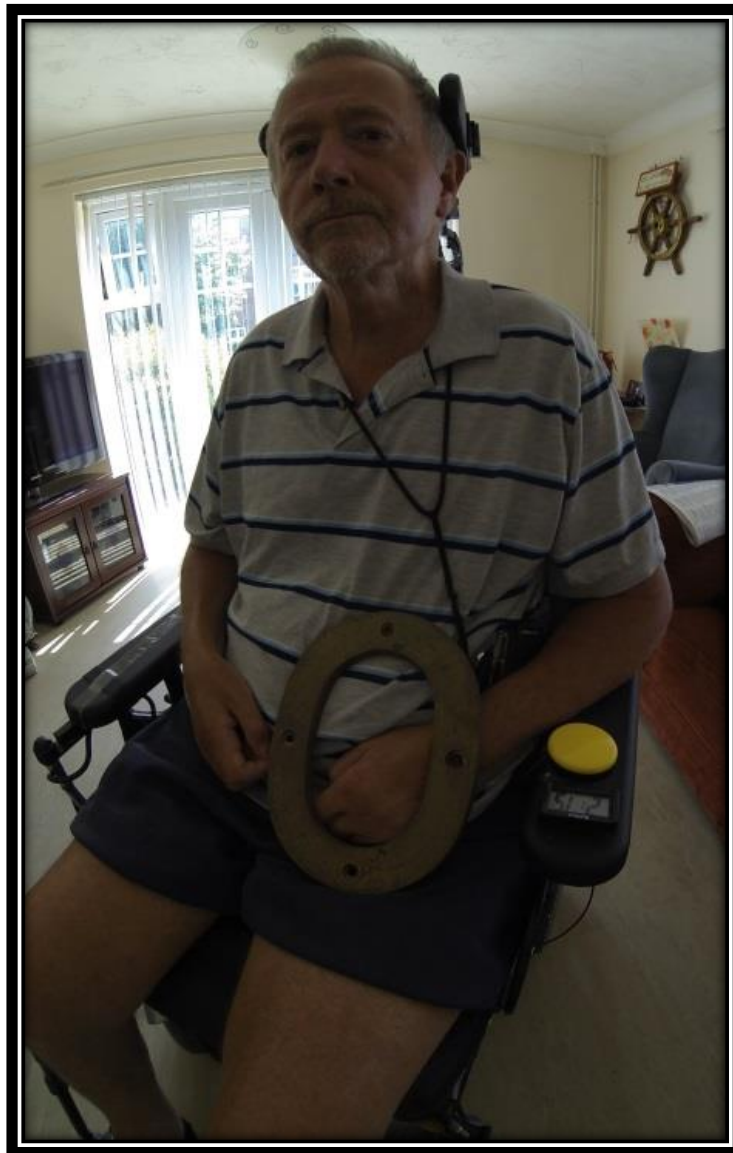
Photo 2, Bob Durant displaying the letter "O" recovered from the wreck site in 1995.

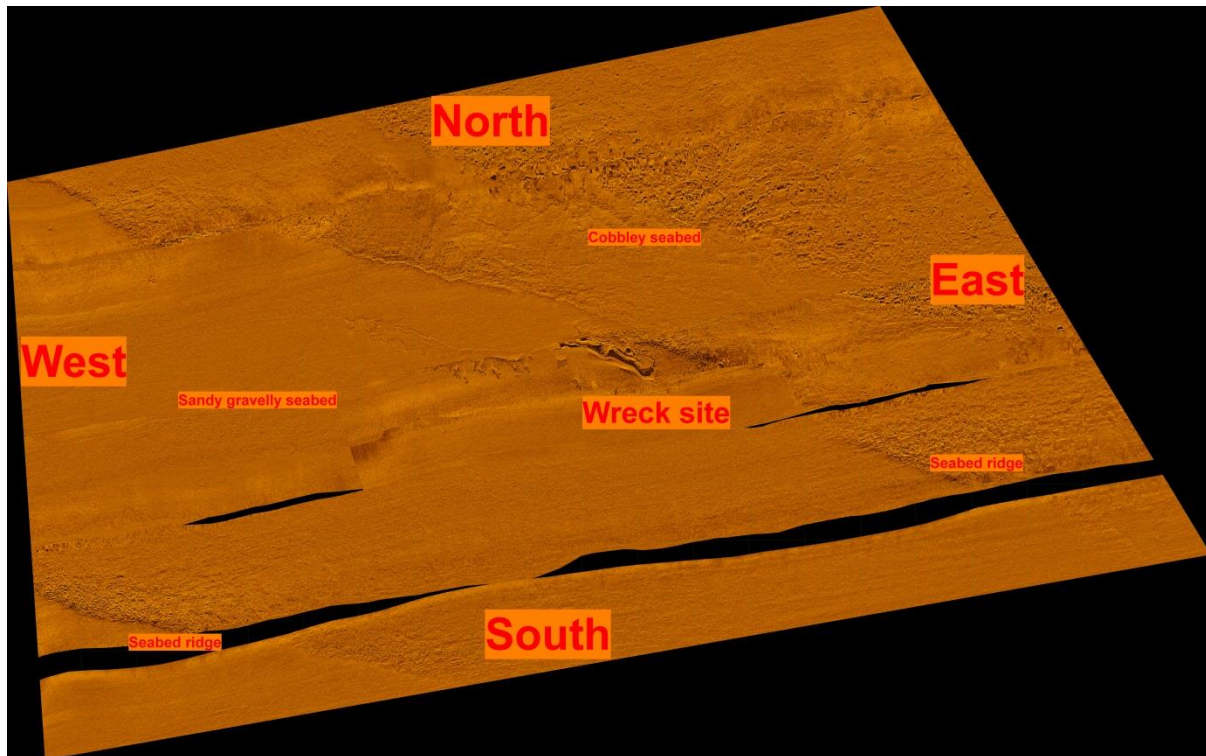
The wreck lays on the edge of a sedimentary boundary which trends $108/288^{\circ}$. The boundary is marked by a low profile ridge; to the north and east of the ridge the seabed has an acoustically mottled and blotchy appearance indicative of a rocky and cobble seabed, whilst to the south and west of the ridge the sea bed has an acoustically uniform, medium intensity, return indicative of a stable sand and gravelly seabed. In the south west there is another rock ridge trending in the same direction as that at the wreck site, Figure 1.

Figure 1, seabed in the vicinity of wreck site.

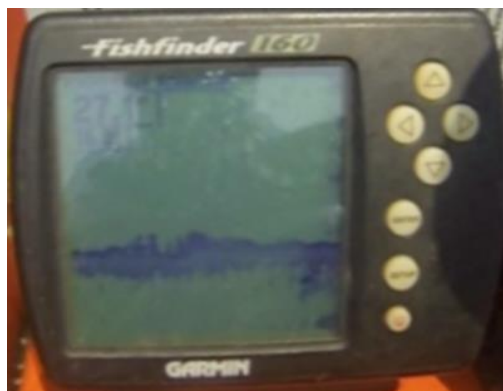
On arriving at the site we deployed the magnetometer and ran a search pattern around the position we had identified in April. Quickly we got a strong hit on the mag and a clear wreck profile on the echo sounder. Further investigation by echo sounder showed the least depth to be 24.8m with the surrounding seabed lying generally at 30m. Pete did an excellent job of shotting the wreck at its shallowest part, amidships and by the boilers.

Photo 7, Wreck trace as seen on the echosounder.

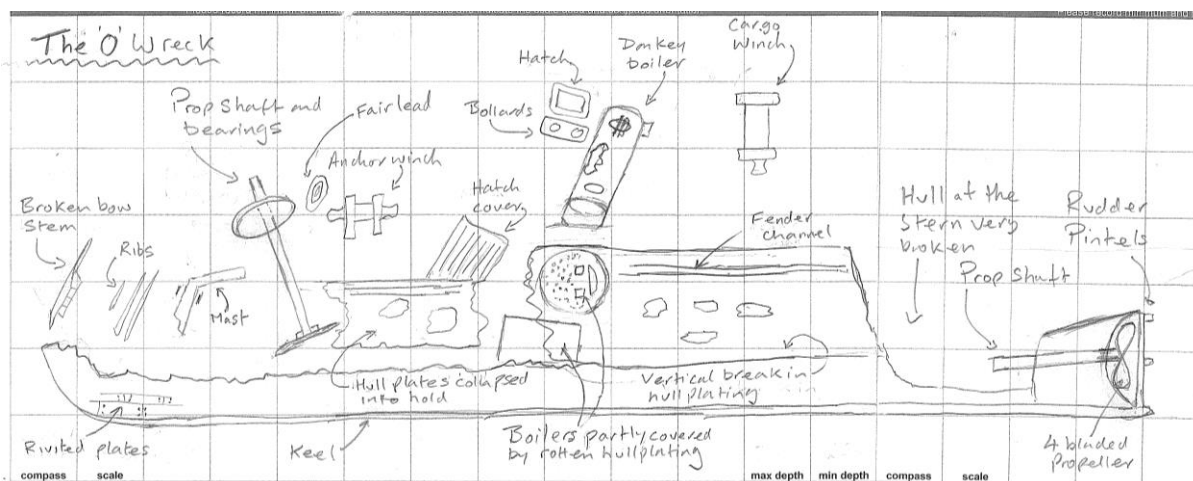
Sketch 1, Sketch of the wreck site showing the location of major components. (The sketch shows the wreck lying on its starboard side but in fact the actual wreck lies on its port side.)

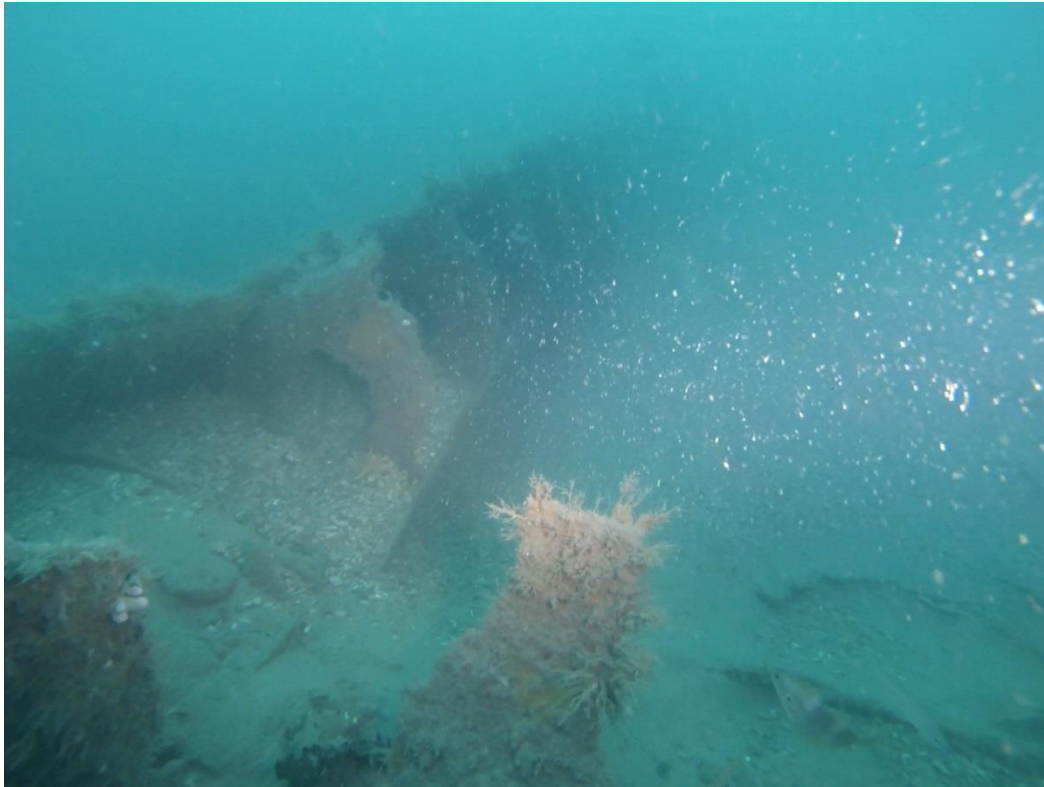
The wreck is lying on its portside; the keel is intact and can be followed from the turn of the bow, at the stem post, to the stern post by the rudder stock which encloses the propeller aperture. Foreword of the boilers, the hull has collapsed and has broken away from the keel revealing the internal frames within the keel section, Photo 9. The starboard hull has fallen into the hold and forms a low lying flat area devoid of many features; it has been displaced from the keel by about 1 to 2 meters. One interesting feature on the hull plating that can be traced along most of the wreck, at the former deck level, is a "U" shaped channel that may have contained wooden fendering, Photos 10 & 11 Deck fittings are also found scattered on the seabed beyond the hull plating at what would have been deck level.

Photo 9, Section of keel showing internal frames, seen from 'inside' the wreck.
